A new experimental snow avalanche test site at Seehore peak in Aosta Valley (NW Italian Alps) – Part II: Engineering aspects

M. Barbero¹, F. Barpi¹, M. Borri-Brunetto¹, E. Bovet¹, B. Chiaia¹, V. De Biagi¹, B. Frigo¹, O. Pallara¹, M. Maggioni², M. Freppaz², E. Ceaglio^{2,4}, D. Godone³, D. Viglietti², E. Zanini²

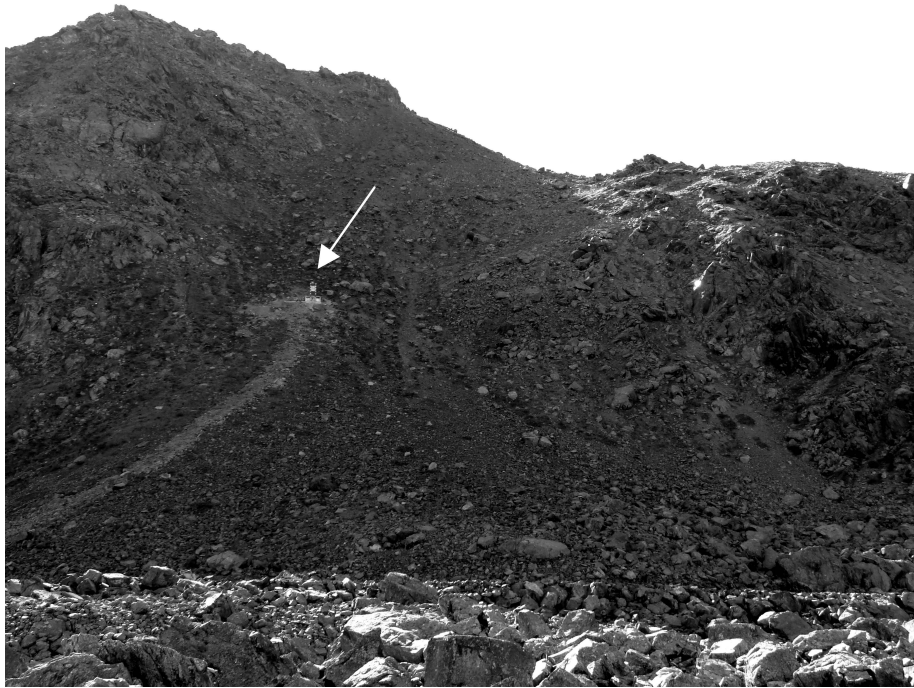
Figure 2: Frontal view of the test site in summer. The arrow marks the obstacle position.

Close to the location of the instrumented obstacle the following types of coverage were observed (see Figure 2):

The obstacle and the measurement systems rest on a concrete slab 3 m long by 3 m wide and 0.6 m thick, placed approximately in the position shown in Figure 2. They were designed to resist the impact of avalanches running along the path and to measure velocity and impact forces. The foundation was embedded so that it emerges only 0.6 m from the natural slope. Gabions filled with material readily available on site were used to support the excavation; this choice helped to minimize the environmental impact, also reducing the amount of concrete to be cast in place (Figure 3).
